September 30, 2013

SUBJECT: Quarterly cap inspection at the San Jacinto River
Waste Pits superfund site

FROM: Valmichael Leos, Federal On-Scene Coordinator
Emergency Readiness Team (6SF-PE)

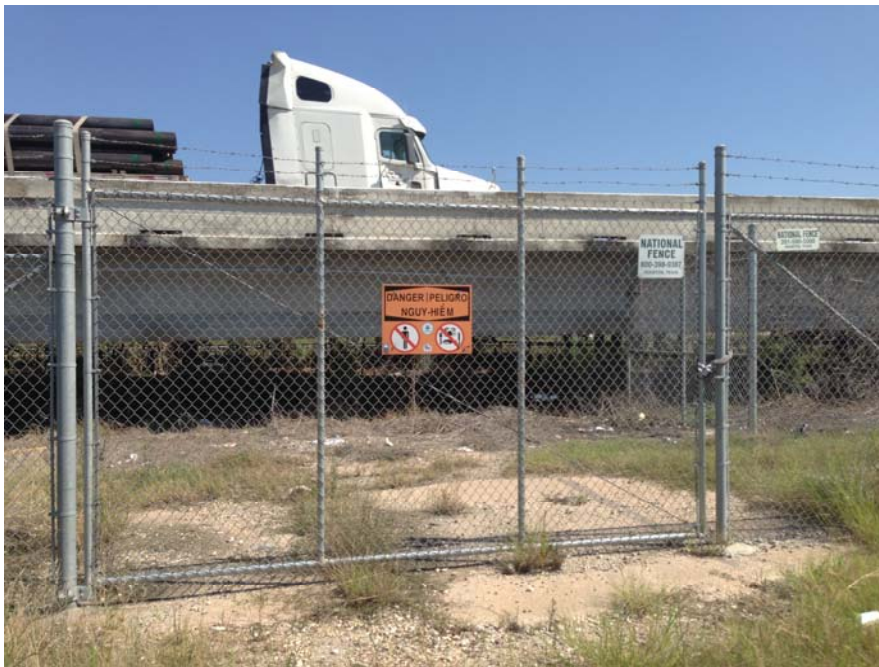
Photo 3- View of Site perimeter fencing Southern Gate, West of San Jacinto River

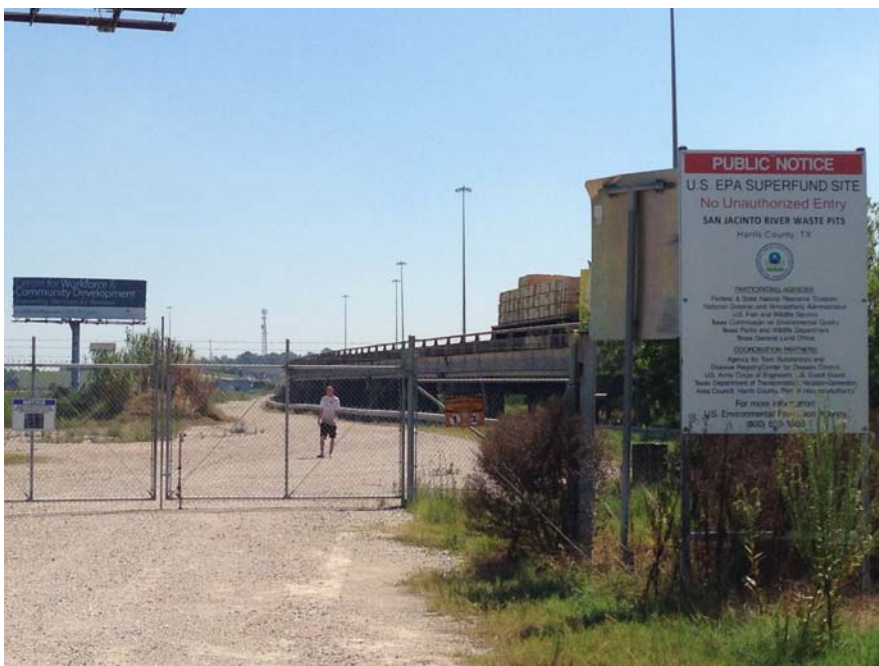
During this Site inspection, a trespasser (See attached photo) was encountered North of IH-10 along the Southern berm. I notified this man that he was trespassing and if he didn't leave the Site immediately I would call the local police to escort him off. He ignored my warning and proceeded to follow me in my rental car on the Site property. I left the Site temporarily, called the police, and waited for them to arrive. About 20 minutes later the cops arrived and escorted the disoriented, bare foot, man off the Site property. Although there was no noticeable holes or gaps in the security fencing, EPA is recommending a complete walk though of the entire fence line to ensure the fencing integrity.

Photo 4- View of Site perimeter fencing Main Gate North along I-10, West of San Jacinto River with Trespasser inside

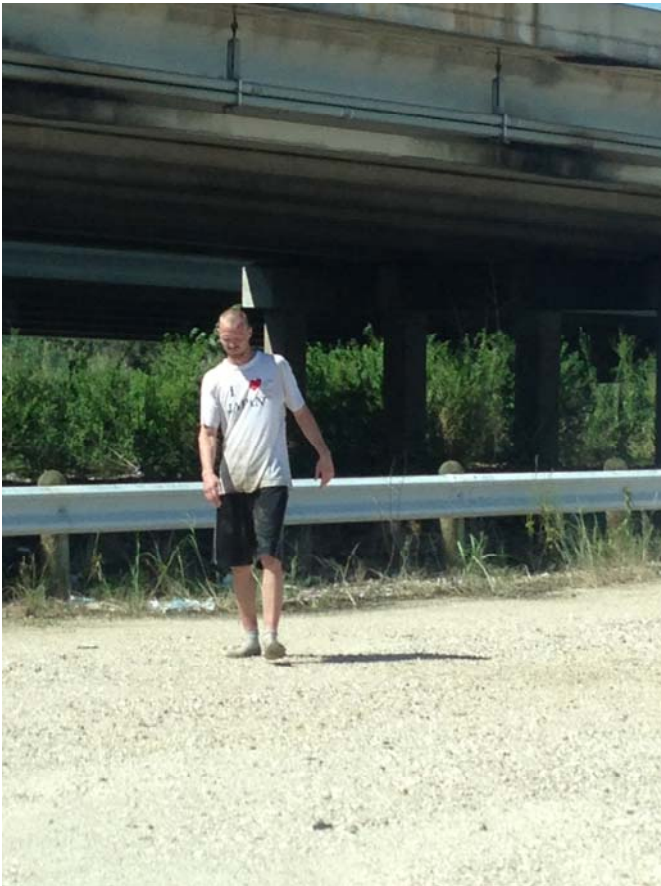
Photo 5- Picture of trespasser who was visibly disoriented, bare foot, with bloody arms and hands

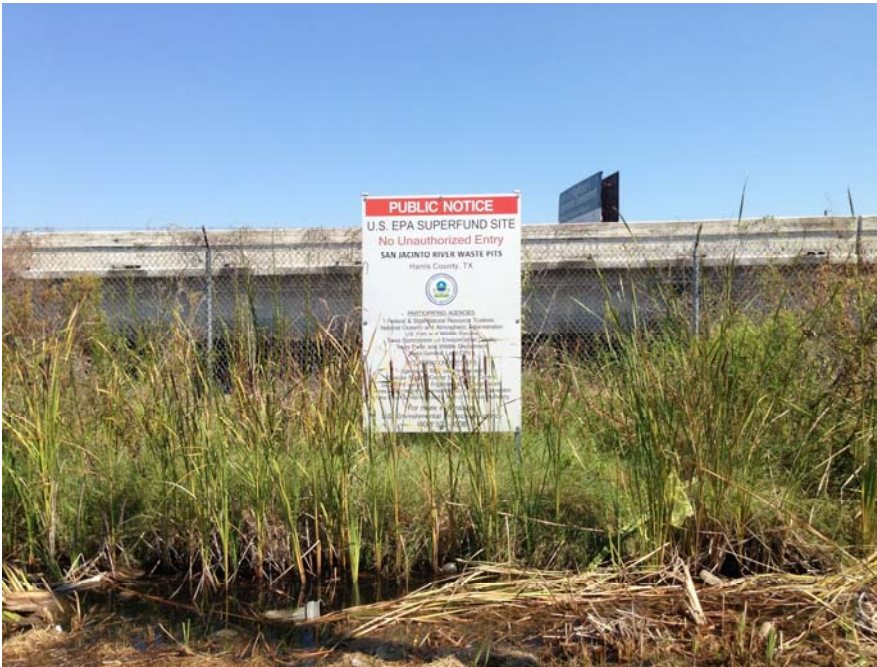
Although the site signage was visible and intact, there was however noticeable vegetative growth surrounding various site signage (See attached photos) that if left unattended would restrict the visibility. Signage needing immediate attention of particular note was along the security fencing South of IH-10 near the southern gate and along the bank of the San Jacinto River West of the armor cap. In general, EPA is recommending that all site signage be reevaluated to ensure no vegetative growth restricts the visibility. In addition to general vegetative site maintenance around the security fencing and site signage, the EPA is recommending that a review of the southern and central berm be conducted to ensure that the vegetative growth on top of the armor cap (See attached photos) does not in any way compromise or degrade the integrity of the armor cap. If left unattended these localized spots of vegetative may have roots that could tear holes or otherwise compromise the integrity of the geomembrane underneath the armor cap thus exposing the waste materials.

Photo 6- Picture of Site signage with vegetative growth from street level along fencing South of IH-10 near southern gate

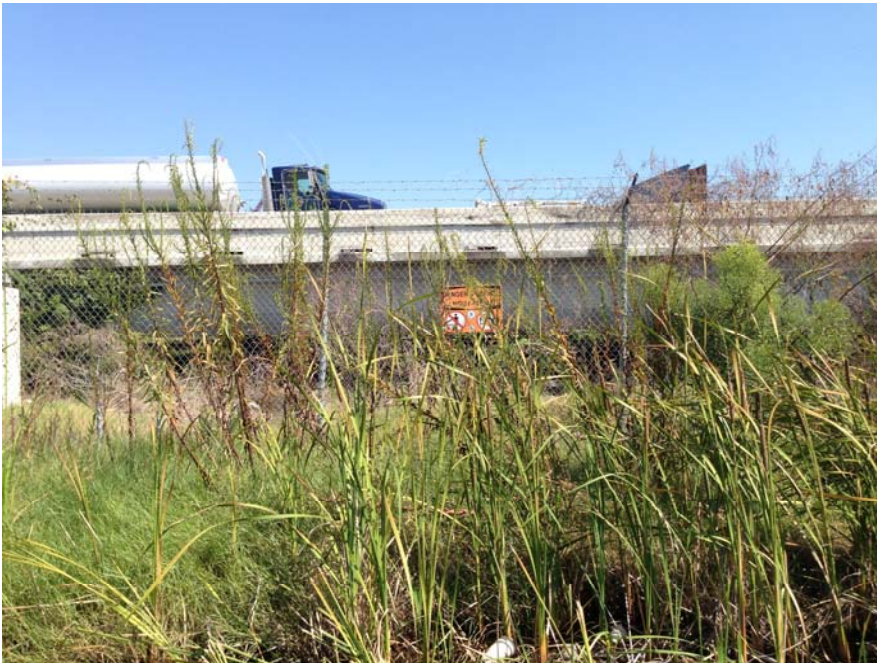
Photo 7- Picture of Site signage along fencing with vegetative growth from street level along fencing South of IH-10 near southern gate

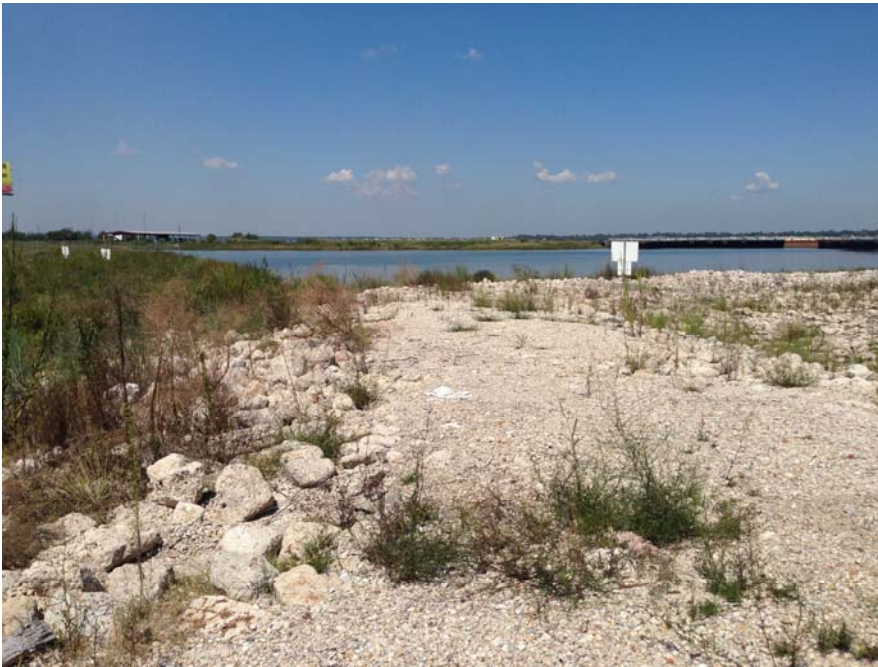
Photo 8- View of southern berm west of central berm with vegetative spots growing out of armor cap

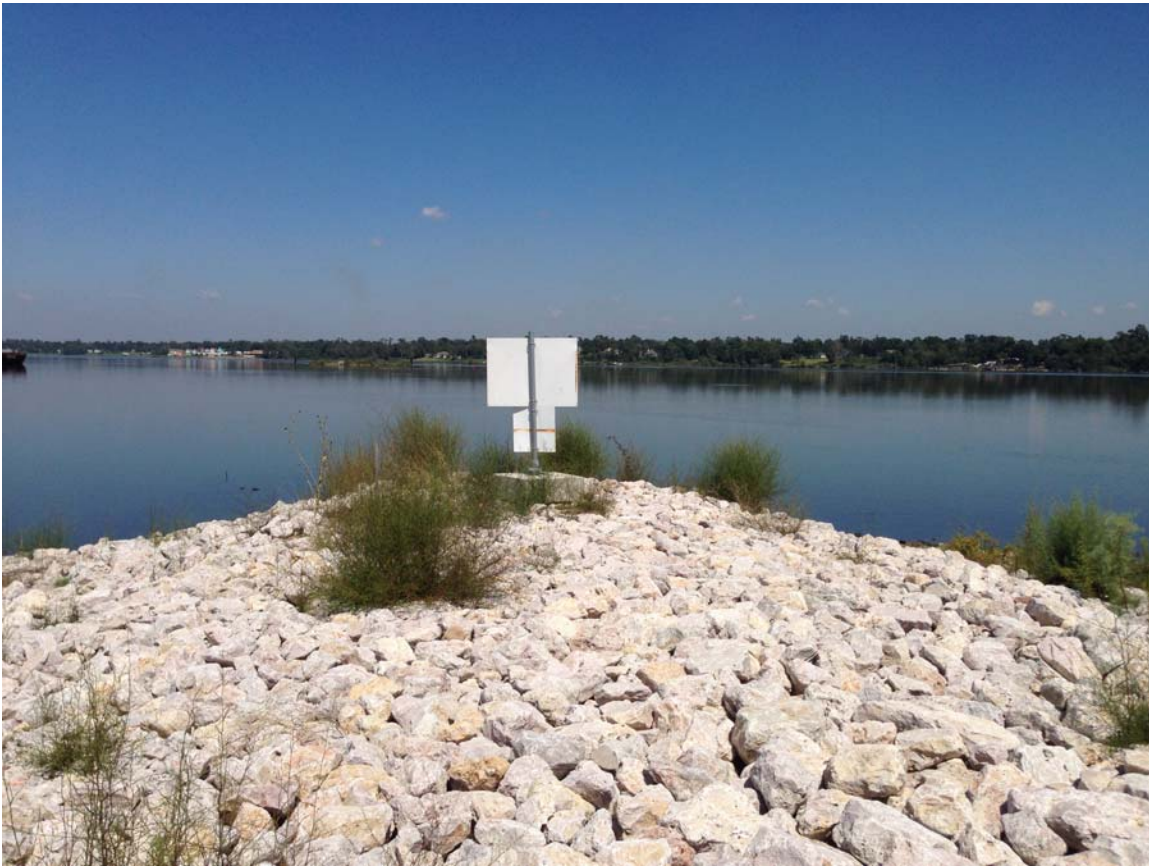
Photo 9- View of central berm with vegetative spots growing out of armor cap
